Accelerated FGD

CORROSION

Understanding the Cause, Finding a Solution

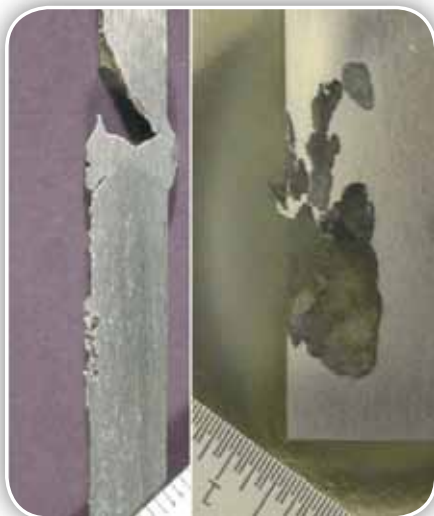
The corrosion most commonly is found below the liquid level in the FGD absorber vessels and piping. It first appears as pitting in weld heat-affected zones, weld metal, and base metal and most often is associated with areas under heavy deposits of gypsum, an FGD byproduct. Corrosion has been serious in some plants and in extreme cases has penetrated vessel walls. The corrosion has been found in many designs produced by several manufacturers.

Representative cross-sections, showing corrosion on Alloy 2205 in a weld and in base metal. Left: through-wall leak in 11/16-inch base metal after 11 months in service. Right: surface and subsurface pitting structure after 11 months in service.

Initial evidence indicates many affected FGD systems are fabricated with one of the most common duplex stainless steels, Alloy 2205, a 22% chromium, 3% molybdenum, 5%–6% nickel, nitrogen-alloyed stainless steel. Some affected systems are made of a similar duplex alloy, 255, with a slightly different composition. Concern is mounting that earlier-generation absorber vessels fabricated with austenitic stainless steels may be subject to corrosion as well, but that the attack has gone undetected. As a result, the EPRI study will investigate duplex stainless steels, stainless steels, and alloys prevalent in today's FGD fleet.

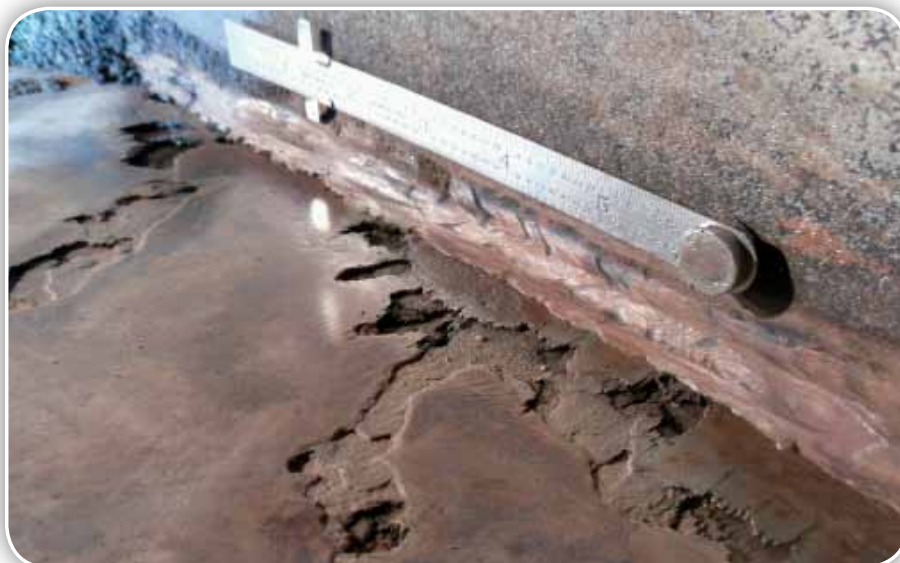
Corrosion damage at a wall and floor joint

The project will identify the most effective mitigation and repair methods to address the cause, including welding, linings, and coatings. It will also review utility field experience with mitigation measures used to date, including welding lap plates over corroded areas on vessel floors and walls, applying coatings, and installing cathodic protection.
