## Robotic Repair Technique Targets Fuel Pool Liners

***EPRI is collaborating with EDF to evaluate a polymer-based repair technique that could be deployed robotically to repair leaks in spent fuel pool liners.***

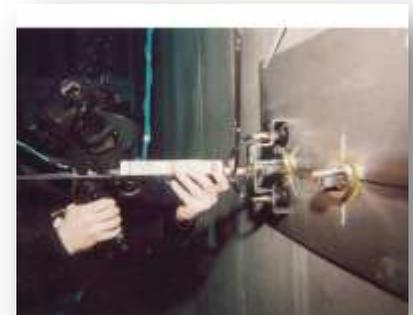
EDF also has been investigating leak repair options and has developed a polymer-based solution that applies a silicone patch in-situ directly on the weld location. This technique, however, requires two manual dives, one to place the tool and inject the silicone into the mold (see photo at right), and a second to disassemble the chassis.

*Manually applied polymer-based solution*
