Subject: Minutes from September 21 to 23, 2010 Cable Users Group Meeting

The September 2010 Cable Users Group Meeting was held in Windsor, CT. The attendees list is contained in Attachment 1. The agenda is contained in Attachment 2. The meeting opened with introductions of the attendees followed by a Round Table discussion of attendee interest and problem areas. The following table lists the presentations that occurred on September 21 and 22 and the associated presenters.

## Cable Users Group Meeting

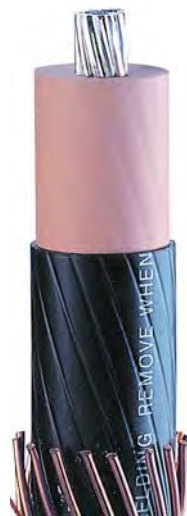
## ACLT Cable Core Summary

- Single conductor, 1/0 AWG, 15 kV cable
- Commercially Available EPR Insulation
- Shielded cable
- Non-jacketed

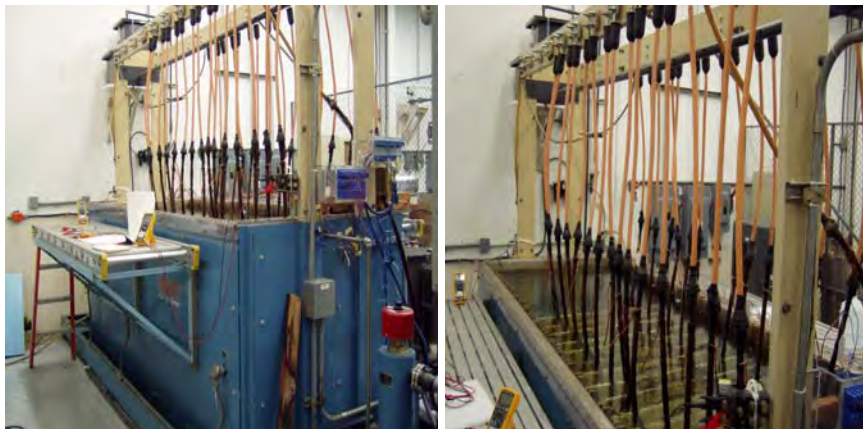
## Laboratory ACLT Aging Model

<b>Cable Preconditioning</b>	Yes 100 hours at 90°C
<b>Media in Conductor</b>	Yes Salt Water (Instant Ocean®)
<b>Conductor Aging Temperature (Stress Cone)</b>	45±3°C
<b>Bath Media</b>	De-ionized Water
<b>Bath Temperature</b>	35±5°C
<b>Aging Voltage</b>	4 Vg (34.4 kV)
<b>Load Cycling</b>	Yes 8 hours on & 16 hours off per day
<b>Aging Period (Maximum if no failures)</b>	150 days

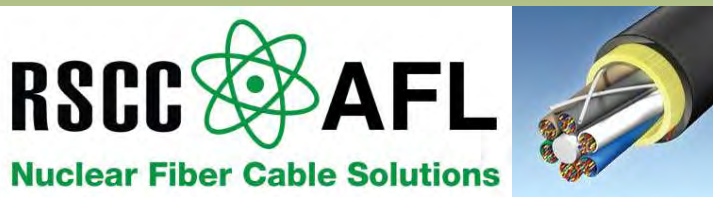
## Fiber Optic Cable

- Rockbestos-AFL Developments
- Standard Fiber to Super Radiation Hard
- Metal Armor Options
- Thermoset Jackets

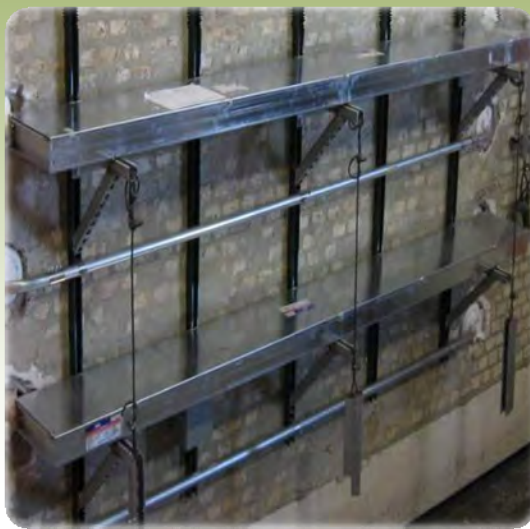
Setup

# UL 2196

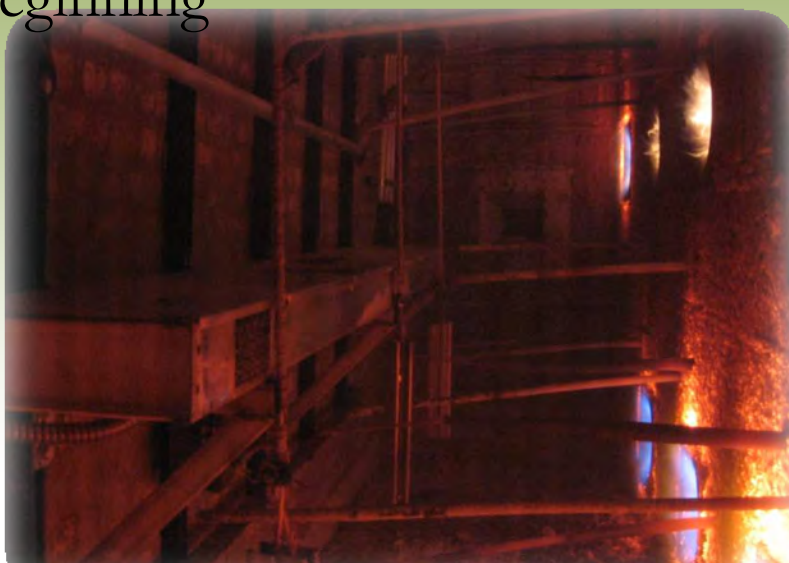
Beginning

# UL 2196

Fire Test

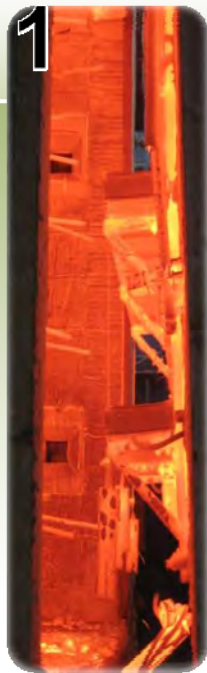
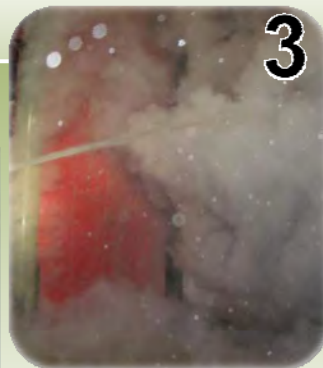
### Hose Test

## UL 2196

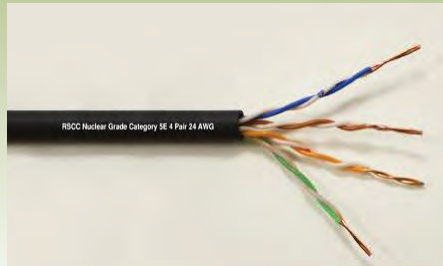
# Communication Cable

Category 5E 4 Pair 24 AWG  
With Crosslinked (Thermosetting)  
Insulation And Jacket

Meets TIA/EIA-568B.2

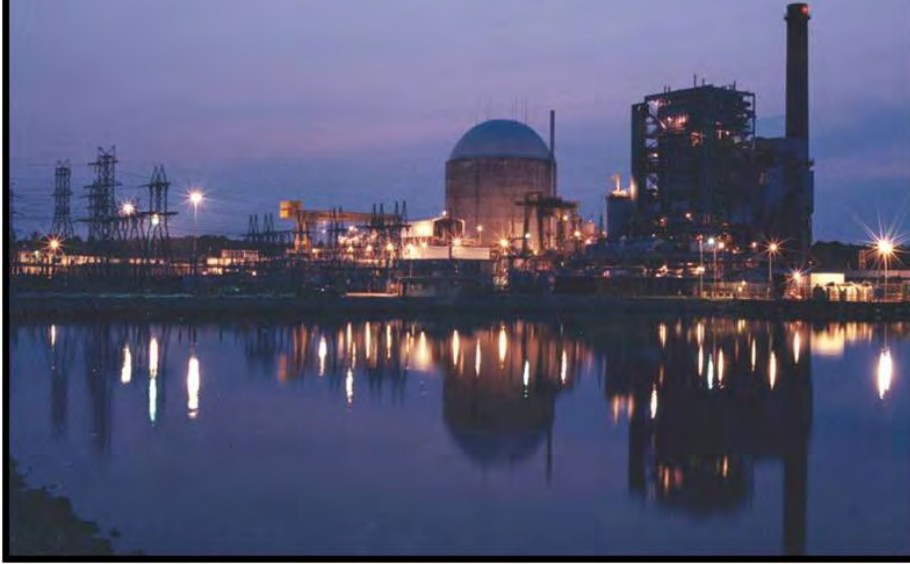
# H.B. Robinson Electrical Event

Robinson breaker control fuse failure. Cable failure caused severe damage to three buses.

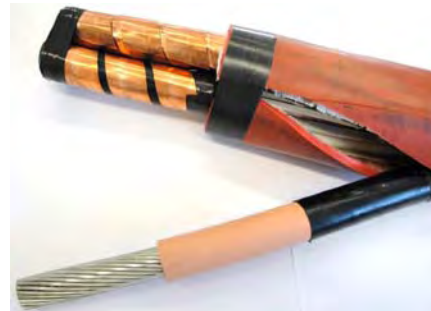
3 x 1 x 300 mm<sup>2</sup> (600 MCM)

## Technical Data of MV Cable 6.6/10 kV

Year manufactured:	1982
Manufacturer:	Cossonay (Switzerland)
Classification:	Class 1E
Standards:	IEEE 383 and different IEC Cable standards
Wire insulation:	EPR
Jacket insulation:	EPR
Test voltage:	15 kV for 24 h
Operating temperature: (Conductor) at 50°C ambient temperature	90°C continuous 130°C for 8 h, max. 100 h per year 300°C for max. 2 sec

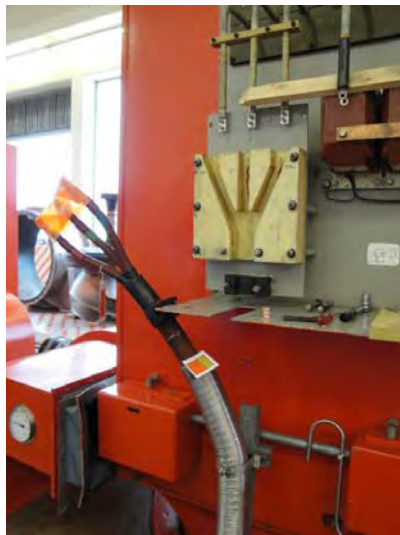
## Configuration at consumer side

- MV Motor for main cooling water pump 1.9 MW**

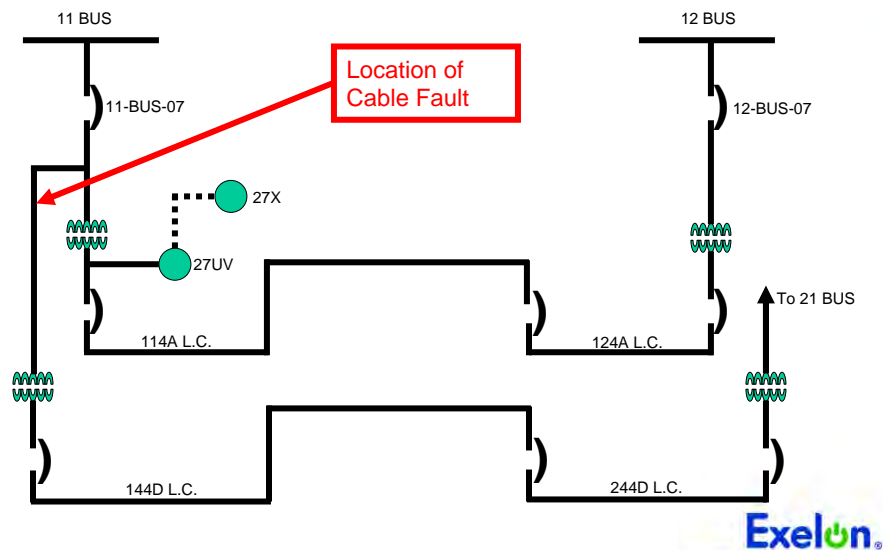
### Simplified Schematic Diagram:

- ✓ This event was initiated by an underground cable fault that resulted in the loss of the 11-Bus-07 feeder breaker due to an "A" phase over-current trip.
- ✓ This caused the 114A and 144D load centers to de-energize. The loss of the 114A caused the operating 1A SCW, 1A1 & 1B1 MG set lube oil pumps to trip. The 144D load center supplies power to the Technical Support Center( TSC).

- ✓ The cable that failed was a 15 KV 250 MCM Anaconda Unishield cable.
- ✓ Cable was an original plant installation.
- ✓ Limerick had scheduled cable for tan delta testing prior to cable failure.
- ✓ Failed section of the cable removed and remaining cable was spliced to a 350 MCM cable.
- ✓ As a result of this cable failure, Limerick has escalated testing of other underground medium voltage cables and recommended replacement of other cables that had poor tan delta testing results.
- ✓ Limerick has also initiated a manhole inspection program and will be installing telemetering level indication system and eventually will install a permanent pumping system.

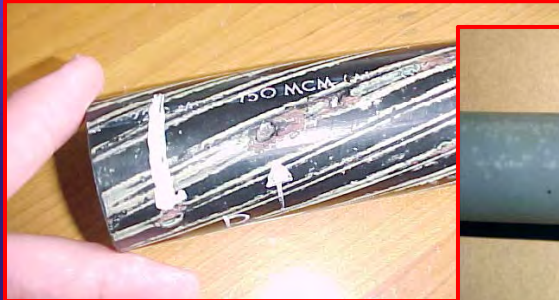
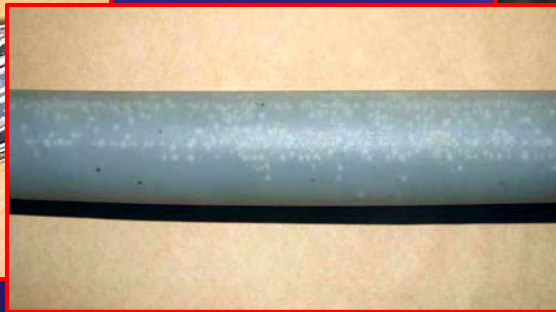
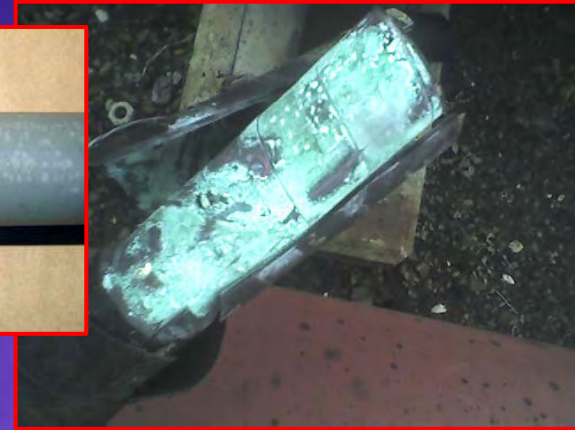
# What Defect/s Are You Trying To Detect In The Cable?

- **Types** : Water Trees, Voids, Workmanship, Electrical Trees, Water Degradation, Shield Corrosion etc.

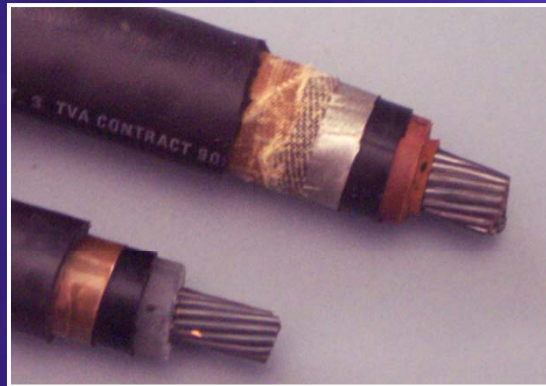
# Types of Insulation

- EPR – Black / Pink / Brown /Orange
- XLPE – PE / XLPE / TR-XLPE
- Butyl Rubber

The Type and /or Interpretation of the Diagnostic Method used will often depend on the type of insulation medium.

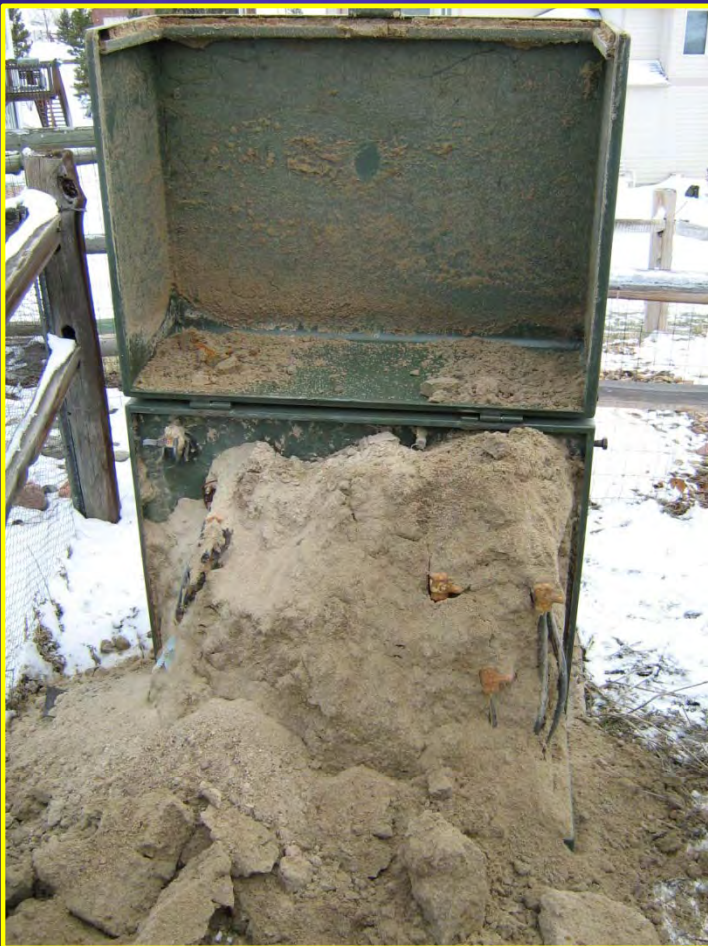
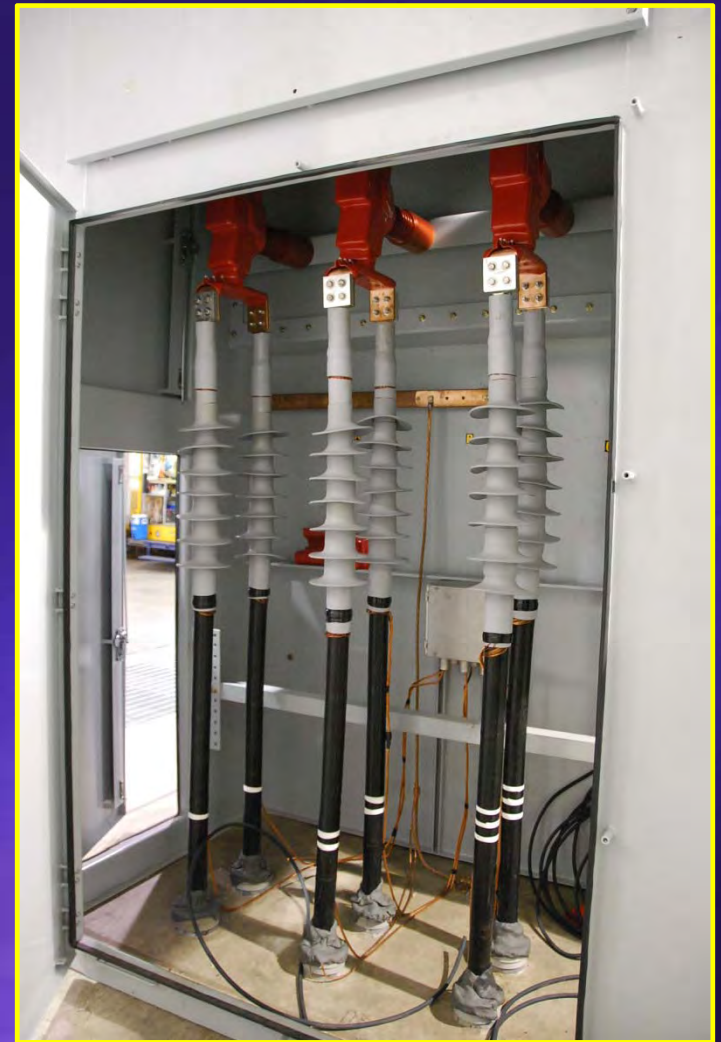
# Termination Clearances:

- Access and clearance is sometimes not an issue.

And Sometimes it is.....

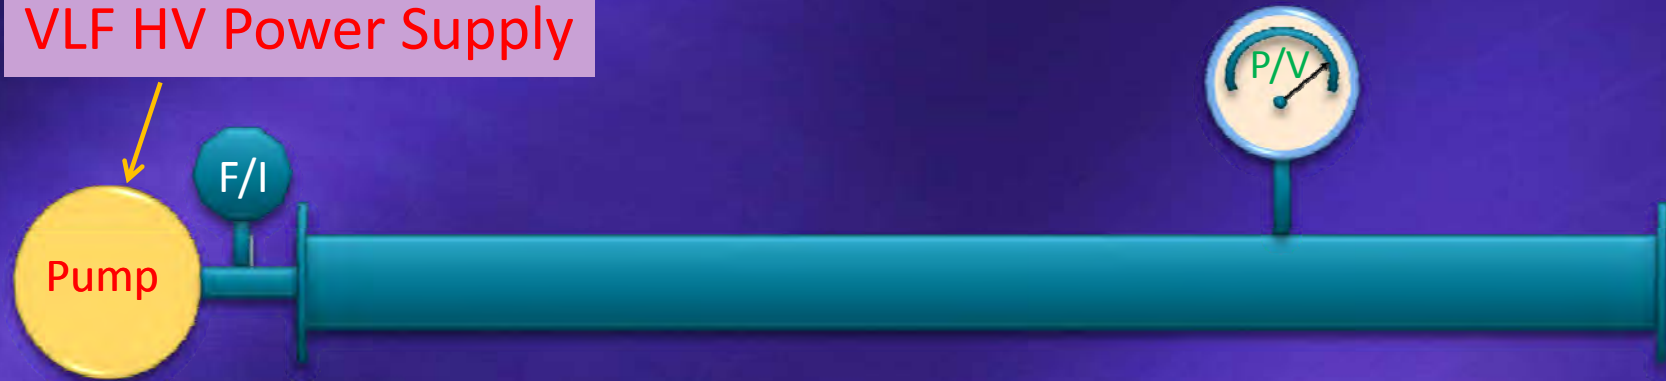
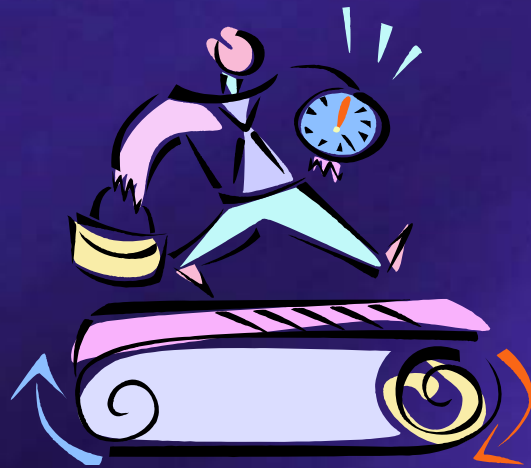
# The Simple Withstand Test

VLF HV Power Supply

Passed

Fails

- Historically a traditional DC Withstand Test was performed in the field to verify the electrical integrity of the insulation of a MV cable. The cables either “held” the voltage or they did not.
- Also referred to as a “Hipot” or “Pressure Test”
- Although some simple parameters are sometimes measured like leakage current etc, traditional DC simple withstands tests where essentially pass / fail type tests.

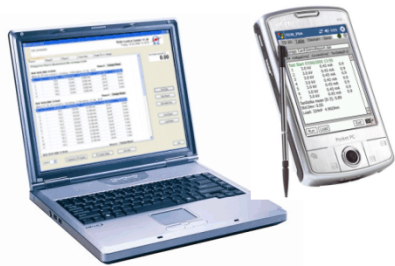
# Tan Delta Setup

Notebook  
or PocketPC

Wireless data transmission  
(Bluetooth)

Direct connection  
to DUT or arbitrary adapters  
like MC, clamps, hooks,

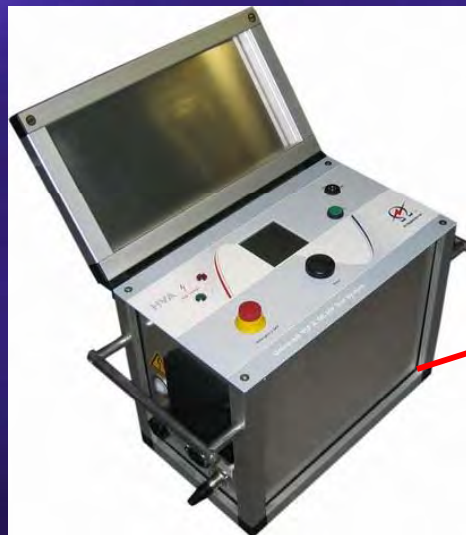
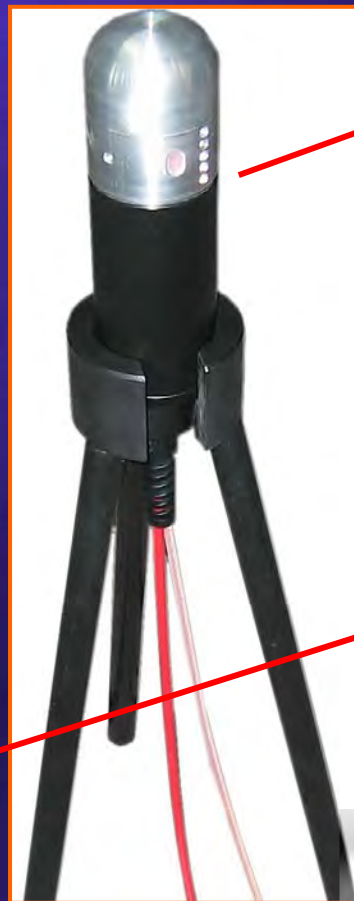
Model TD30

Model HVA30/HVA60

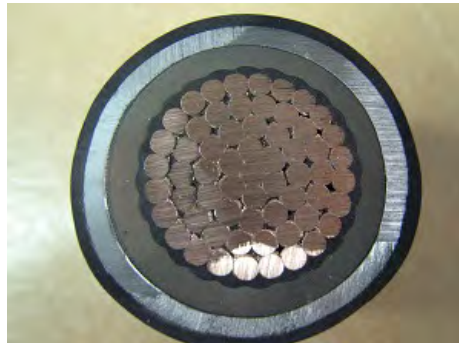
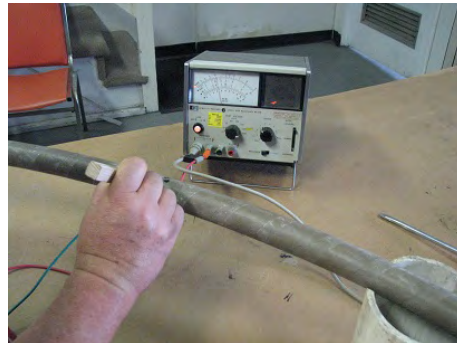
## Water Trees in Rubber Insulation

Brown EPR

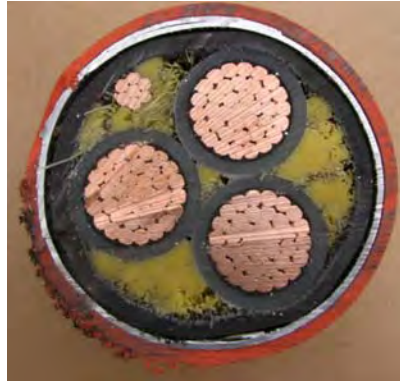
## 3/C Unshielded, Armored XLPE Insulated Cables With Weak Insulation

Natural XLPE insulation  
Cable Length: 3 ½ ft – 14 ft

- Testing –
  - 0.1 Hz Dissipation Factor measured
- Results -
  - Dissipation Factor values: high
  - Dissipation Factors vs. applied voltage: flat
  - AC Breakdown voltage of the insulation: high
- Conclusions –
  - Cable is in good condition
  - Dissipation Factor as a diagnostic tool – no inference

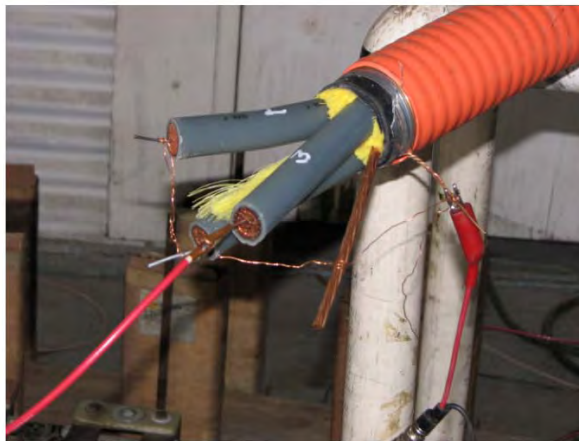
## Test Set Up

Connection of cable sample during DF measurement at 60 Hz.

- Testing –
  - Only 60 Hz (bridge) dissipation factor measured
- Results –
  - Very low apparent capacitance
  - Dissipation factor: very high and flat
  - AC breakdown voltage of the insulation: high
- Conclusions –
  - Cable is in good condition
  - Dissipation Factor as a diagnostic tool – no inference

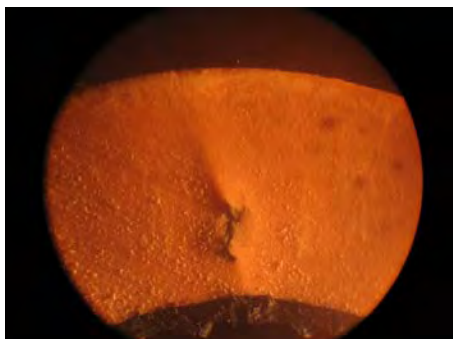
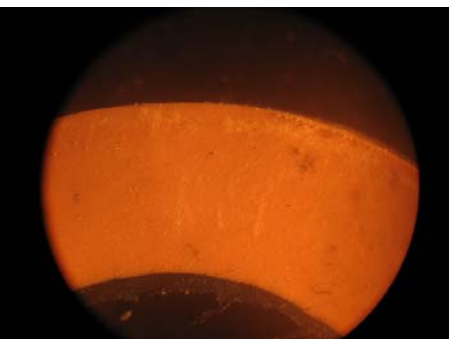
## Photomicrograph of Laboratory Failure Insulation Wafers

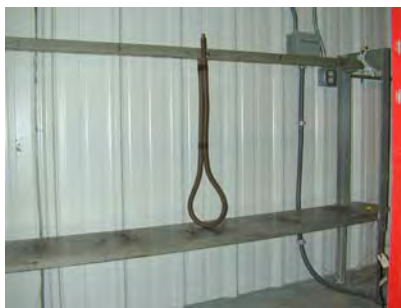
## U-Bend Plate Test

- #2 AWG 15kV Cable
  - 175 mil Insulation
  - Remove
    - Jacket
    - Metallic Shield
    - Insulation Shield
  - Test Voltage
    - 44kV (250V/mil)
