Accelerated FGD

CORROSION

Understanding the Cause, Finding a Solution

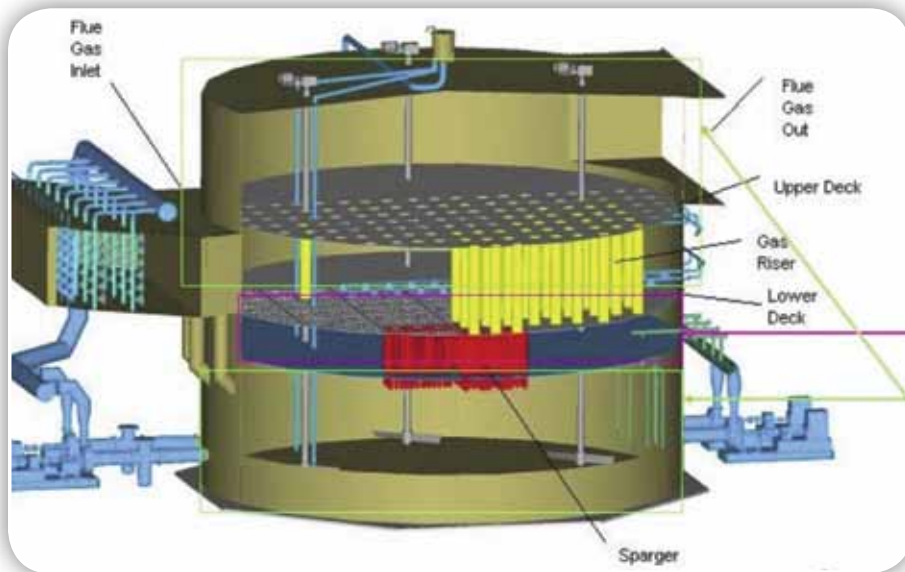
Jet bubble reactor. For this schematic, the purple box indicates Alloy 255 duplex stainless steel in the froth zone (wet/dry zone) of the shell, and the green boxes are Alloy 2205 duplex stainless steels above and below. Illustration courtesy of M. J. Crichton.
