Assessing the Reliability of Digital Meters

EPRI Testing, AEP Field Application Validate Reliable, Cost-Effective Weld Repair Technique

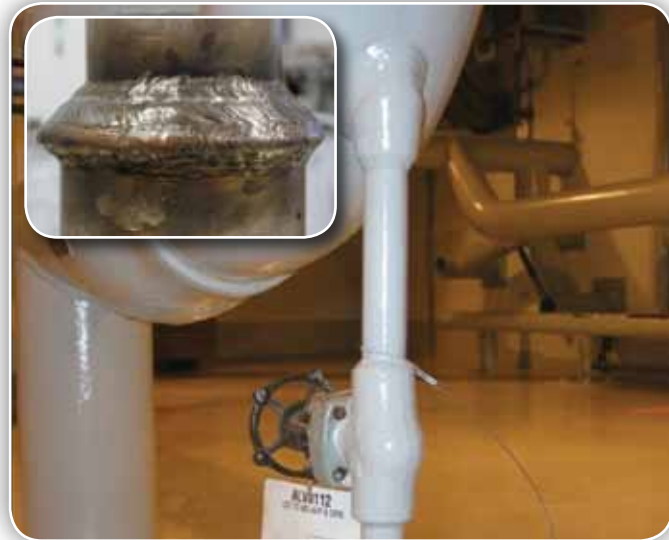
Nuclear power plants have thousands of socket welds that are susceptible to fatigue failures.

The technique uses a structural weld reinforcement that covers the outside surface of the pipe, fitting, and original weld. First, the active leak is controlled by peening weld metal over the fatigue crack. The crack is then sealed with a weld bead over the peened area. Finally, the structural overlay weld is added, using weld metal that matches the base metal composition.
